# SPM & TANKER MOORING HAWSER

Service Life Prediction,  
Replacement Criteria and Testing Services

Technical Notes 08, January 2005

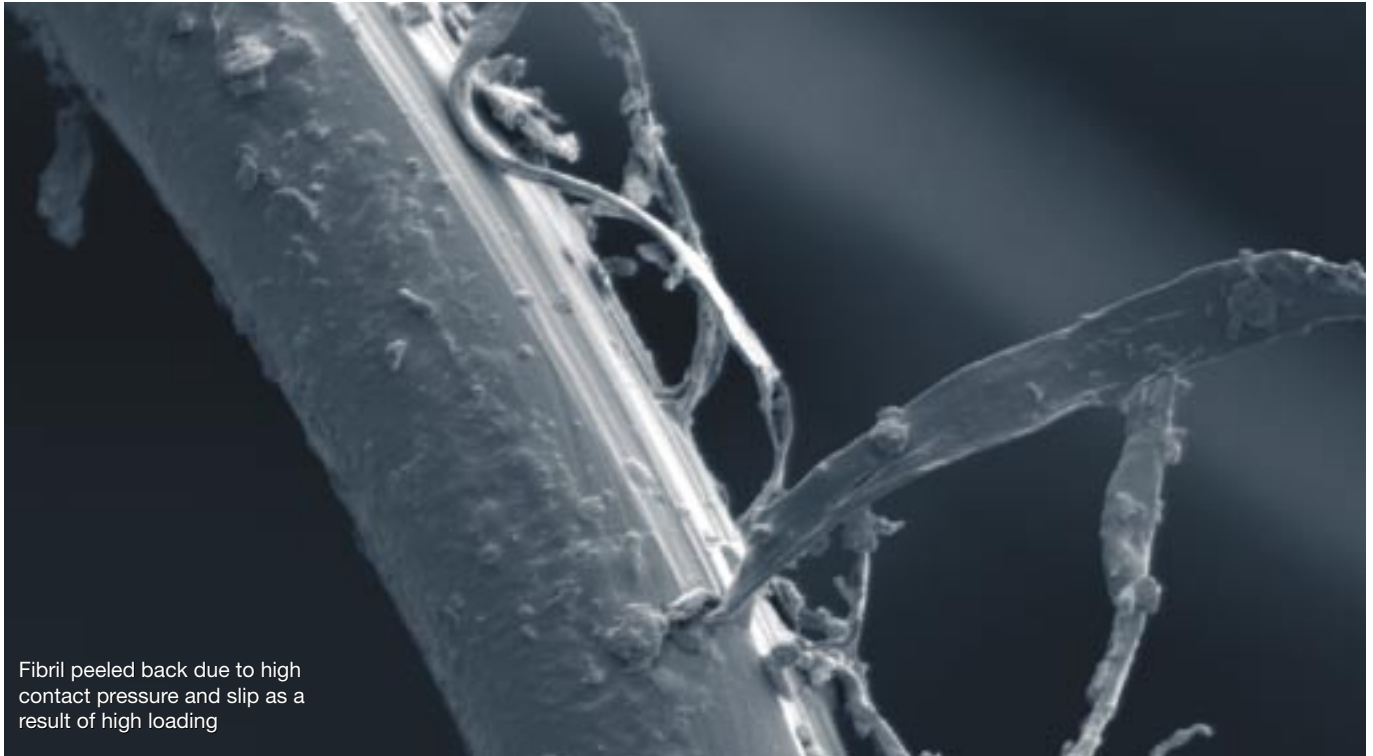
Fibril peeled back due to high contact pressure and slip as a result of high loading

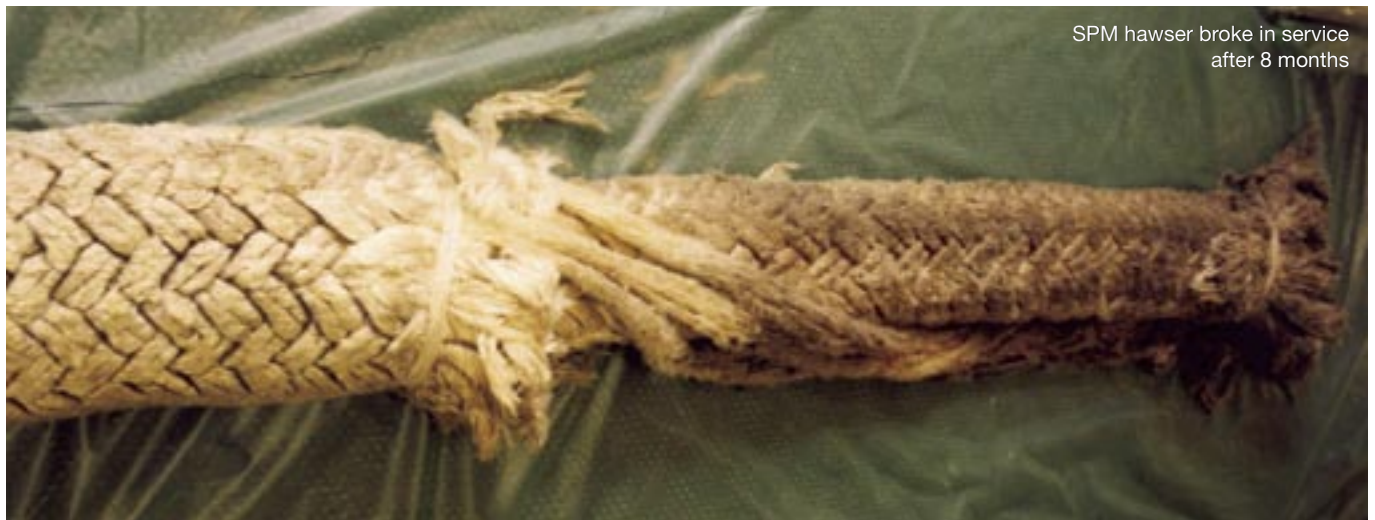
SPM hawser broke in service after 8 months

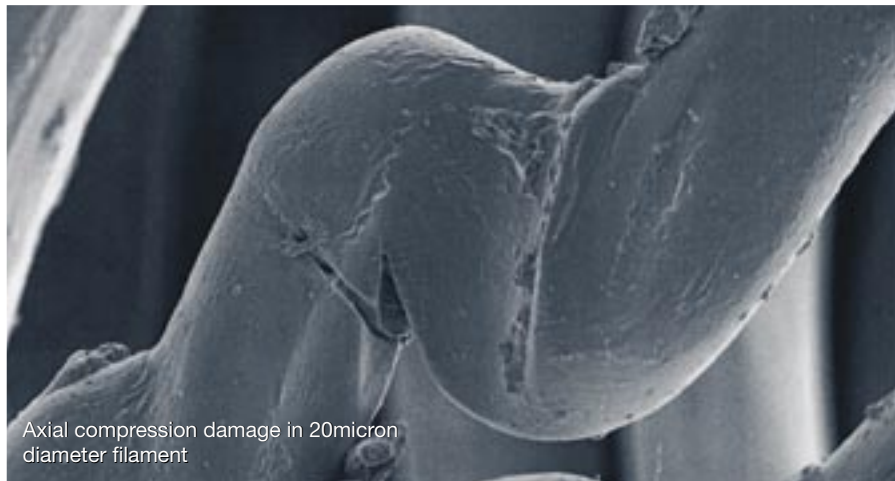
Axial compression damage in 20micron diameter filament

British Standards and SEM/optical microscopy analysis of yarn wear and fatigue characteristics as shown below. Alternatively, all types of rope, whatever condition, can be spliced by TTI and hawser residual strength determined.

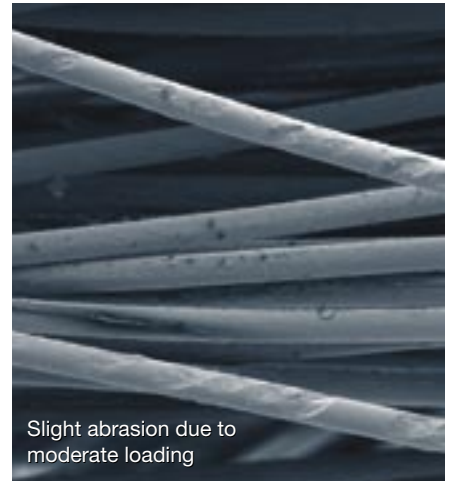
Slight abrasion due to moderate loading
