# **FATIGUE MECHANISMS AND RESIDUAL PROPERTIES OF POLYESTER ROPES**

**S.J. BANFIELD, TENSION TECHNOLOGY INTERNATIONAL LTD  
N. CASEY, NATIONAL ENGINEERING LABORATORY  
U. BINDINGSBO, NORSK HYDRO AS**

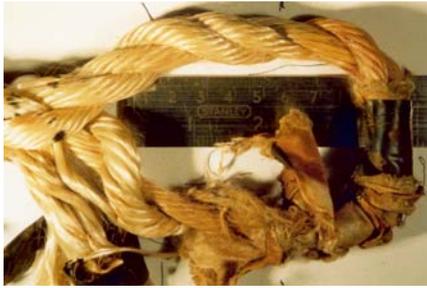
Figure 5. One strand failed at the tangent contact of the eye on the spool

One strand failed in the eye at the tangent contact on the spool as shown in figure 5. No further examination of this eye was conducted since the damage was done, more could be learnt from examining the opposite end eye that was still intact as shown in figure 6. A single layer of Dyneema cloth was wrapped in a spiral direction around the eye. The Dyneema cloth had not worn through on the stainless steel spools. When the cloth was removed as shown in figure 7 the eye had severe abrasion damage around the contact on the spool with the maximum damage on the rope in the sliding zone at the tangent contact on the spool. The outside layer of yarn in the strand had virtually completely worn through. A close up photograph in figure 8 revealed abrasion failed filament ends. It can also be seen that there was negligible inter-strand abrasion in this same region. There was some rust deposit on the strand and it was suggested this may have accelerated the abrasion. However, the absence of inter-strand abrasion proves this theory not to be possible.

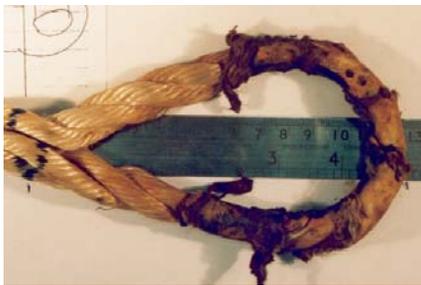
Figure 6. Intact eye with single layer of Dyneema cloth wrapped in a spiral direction around the eye. The Dyneema cloth had not worn through on the stainless steel spools.

A high D/d ratio of 5/1 had been used for the spool and this had resulted in a high axial induced rope strain creating a sliding motion on/off the spool. The single layer of Dyneema cloth would promote sliding at the interface between the sub-rope and the cloth. Since Dyneema has a better wear performance than polyester, the polyester had preferentially worn. As previously found (ref 10), two layers of Dyneema cloth would prevent such damage since the coefficient of friction Dyneema on Dyneema is lower than Dyneema on polyester. Thus, the sliding interface would be between the cloth where any abrasion, if it ever occurs, would not be sacrificial since this is non axial load bearing component.

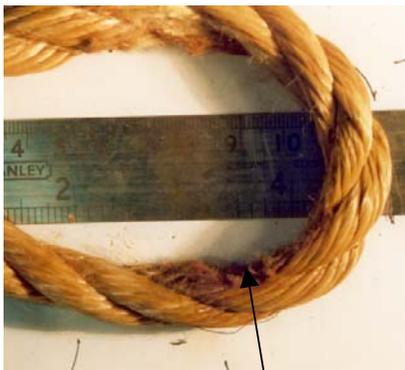
Figure 7. When the cloth was removed as shown in figure 6, the eye had severe abrasion damage around the contact on the spool with the maximum damage on the rope in the sliding zone at the tangent contact on the spool. The outside layer of yarn in the strand had virtually completely worn through.

It is clear that the combined effect the single cloth layer and the high D/d ratio had caused the abrasion damage.

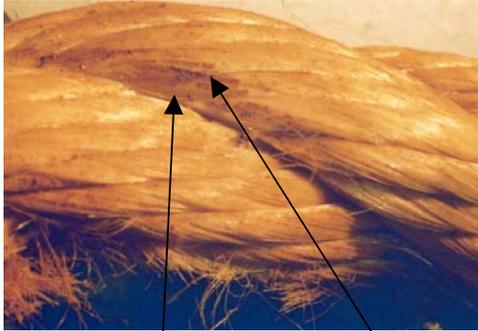
Figure 8. A close up photograph of figure 7 revealed abrasion failed filament ends. It can also be seen that there was negligible inter-strand abrasion inter-strand at this same region. There was some rust deposit on the strand and it was suggested this may have accelerated the abrasion. However, the absence of inter-strand abrasion proves this theory not to be possible.

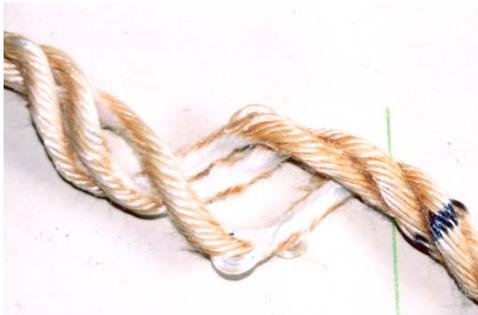
Figure 9. There was significant inter-strand abrasion along the entire midspan length between splices. A typical region is shown where the lay has been opened to reveal the strand contact.

There was significant inter-strand abrasion along the entire midspan length between splices. A typical region is shown in figure 9 where the lay has been opened to reveal the strand contact. A close up photograph of the abrasion damage is shown in figure 10 where the broken ends of the filaments are a few millimetre long. Before these broke and protruded out of the rope, they would have been under the strand-on-strand contact region where the pressure is highest. Also, the slip motion between strands is highest at the line contact between strands where the abrasion damage occurs.

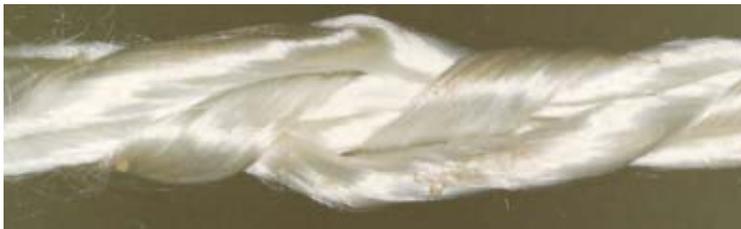
Figure 12. An examination of the sub-rope splice revealed no inter-strand abrasion at all in the clear rope

A fatigue test (ref 3) conducted on a 5t polyester parallel strand rope to the same test loads as above was stopped after 12 million cycles. An examination of the rope revealed no inter-strand abrasion at all in either splices as shown in figure 11 or clear rope in figure 12. In table 3 the textile yarn average residual strength was very high at around 90%, although there was some early indication of fatigue damage with some yarns significantly down in strength to 57%. In contrast, a large number of yarns exceeded 100% and as high as 107%, so there is clearly no internal abrasion. This raises an important question, why the difference in internal abrasion compared to the 48 million cycle test? The 48 million cycle sub-rope had a significantly higher helix angle of around 13 degrees compared to the 12 million cycle sub-rope in the rope. It is believed that the higher inter-strand contact pressure and slip had caused the abrasion damage in the 48 million cycle test and was not due to the extra cycles. Certainly there will be a relationship between mean load, load range, helix angle and contact pressure and slip. These tests indicate that there is a cut off where no internal abrasion will occur with cycles providing the slip and pressure is sufficiently low.
